HP Pavilion ze4530US CD Rom Replacement

Replace a CD Rom that is not capable of reading discs.

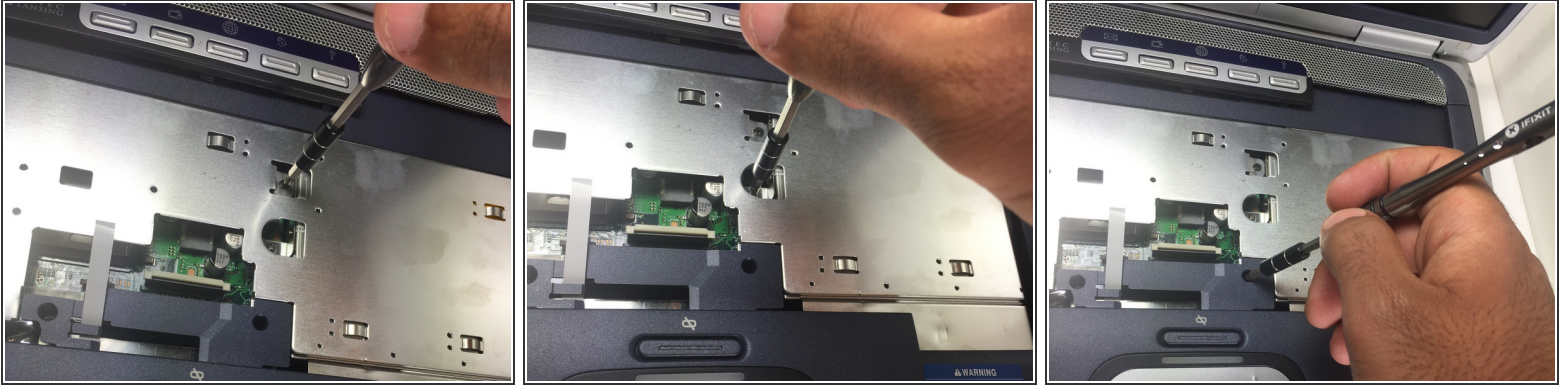
Step 1 — CD Rom

- Unscrew three screws from under the keyboard. The keyboard must be removed for this process.

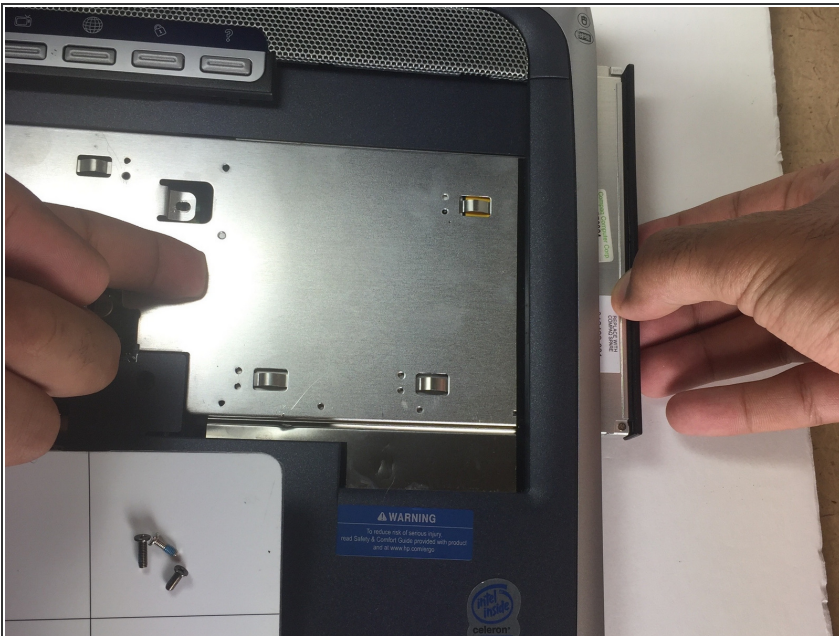
Step 2

- After the screws have been removed, use one finger to push the CD Rom out while the other hand is simultaneously pulling the CD Rom out.

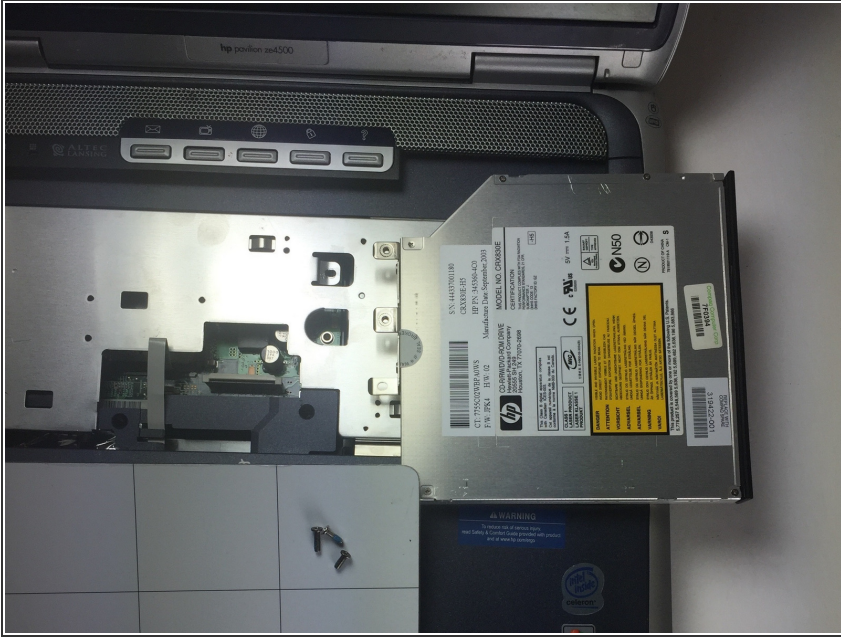
Step 3

- The CD Rom has been successfully taken out.
